Evaluating Residential Structure Ignition Potential
Structure Documentation and Installation on Site in the NWT

Progress Report for Helena Marken
FireSmart BC
July 2023

MYAC Consulting Inc.
23046 Township Road 514
Sherwood Park, Alberta
T8B 1K9

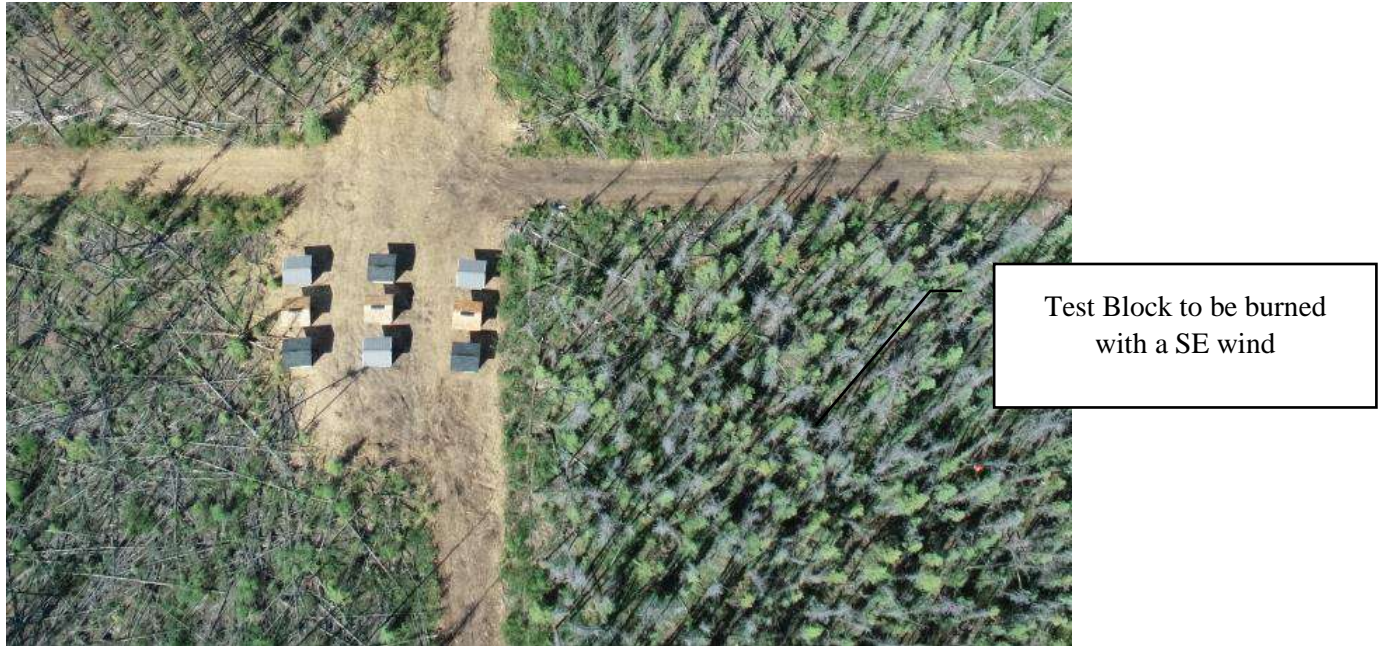
Figure 5 Overhead View of Nine Cabin Site at NW Corner of Block to be Burned (photo courtesy of Brandon MacKinnon – FP Innovations)

Figures 5 through 7 show an overhead view of the structures after assembly and placement. Note that the structures were placed in three rows (separation distance ~ 6 m) of three cabins. Each row contains a vulnerable (cedar), present day (vinyl) and a fire resistant (cement board) structure. The vulnerable structure was placed in the center of each row so that, in the event it ignited, it would provide a significant threat to the adjacent structures. Present day and fire resistant structures were alternated in each row to remove any potential bias that might result from placement.

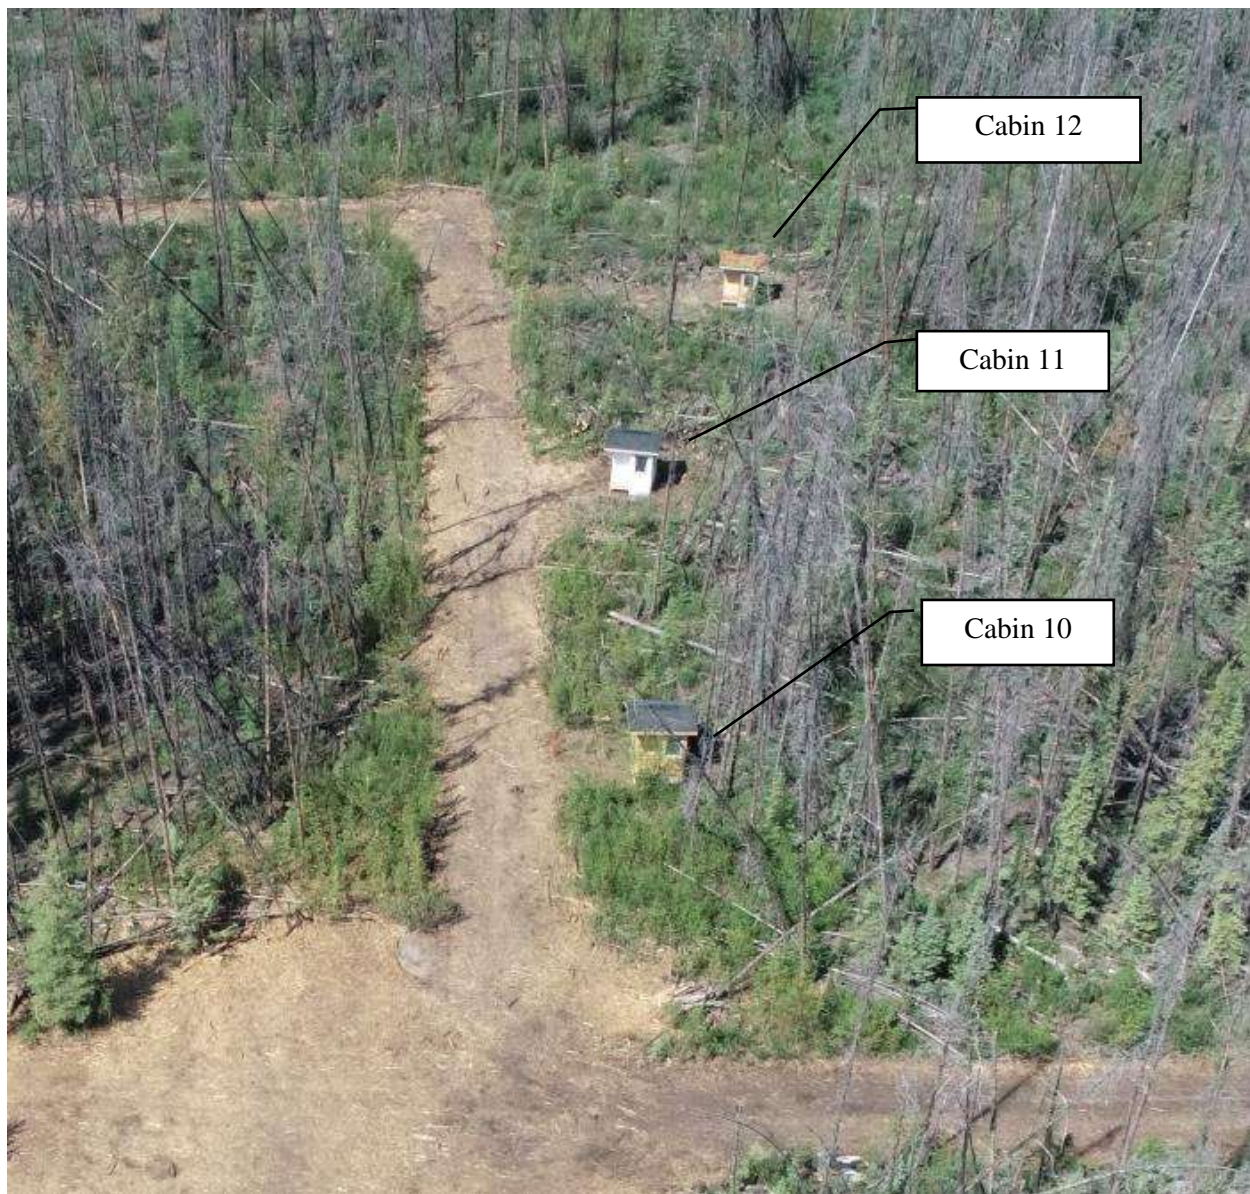
Figure 9 Three Cabin Site for Structure Protection Testing (photo courtesy of Brandon MacKinnon – FP Innovations)

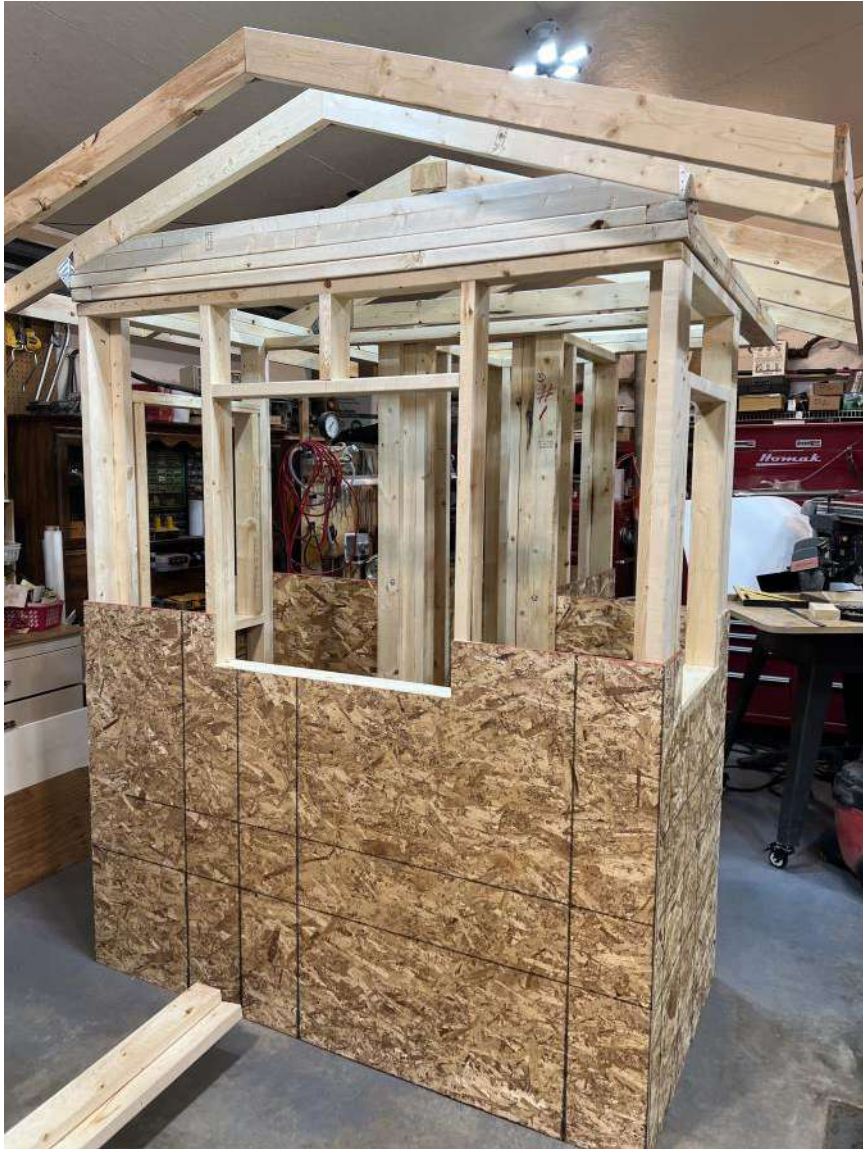
Figure 12 Basic Frame Common to All Cabins

All cabins were constructed using nominal 2x4 frames covered in 9.5 mm (3/8 in) oriented strand board sheathing and a polyspun olefin moisture barrier (Tyvek or Typar). While it was recognized that most present day structures are constructed with nominal 2x6 framing the logistics of getting the structures to a remote site dictated some compromises in terms of mass. It was felt that this deviation from “normal” construction methods would not compromise the performance of the structures in terms of how they would behave when threatened with embers or flames. Figure 12 shows the framing system used for all cabins. Rough window openings were 760mm x 760mm (30 in x 30 in) (front window) and (510 mm x 760 mm) (20 in x 30 in) (side windows). Window units in all cabins are sealed (two glass panes) with vinyl frames. The roof structure used, Figure 13, was the same for all cabins in order to ensure the roof could be lifted off and transported as a unit. The structure frame was made to break into two pieces (main cabin body and tail) for ease of handling and transport (Figure 14). All cabins have a strip of cement board (approximately 200 mm tall) applied at ground level to simulate a foundation (non-combustible).

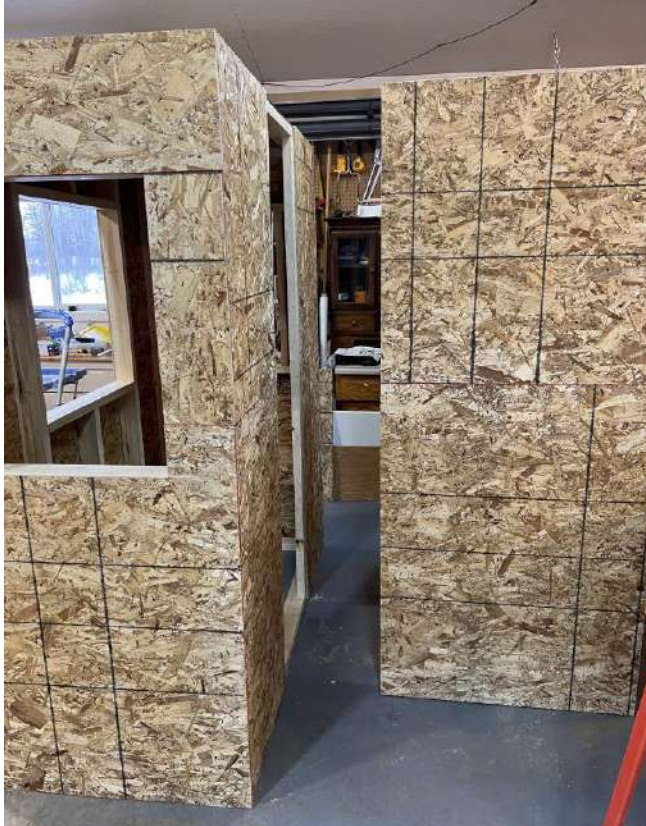
*Figure 15 Basic Frame of Cabin Broken into Two Parts
(main body on left and tail on right)*

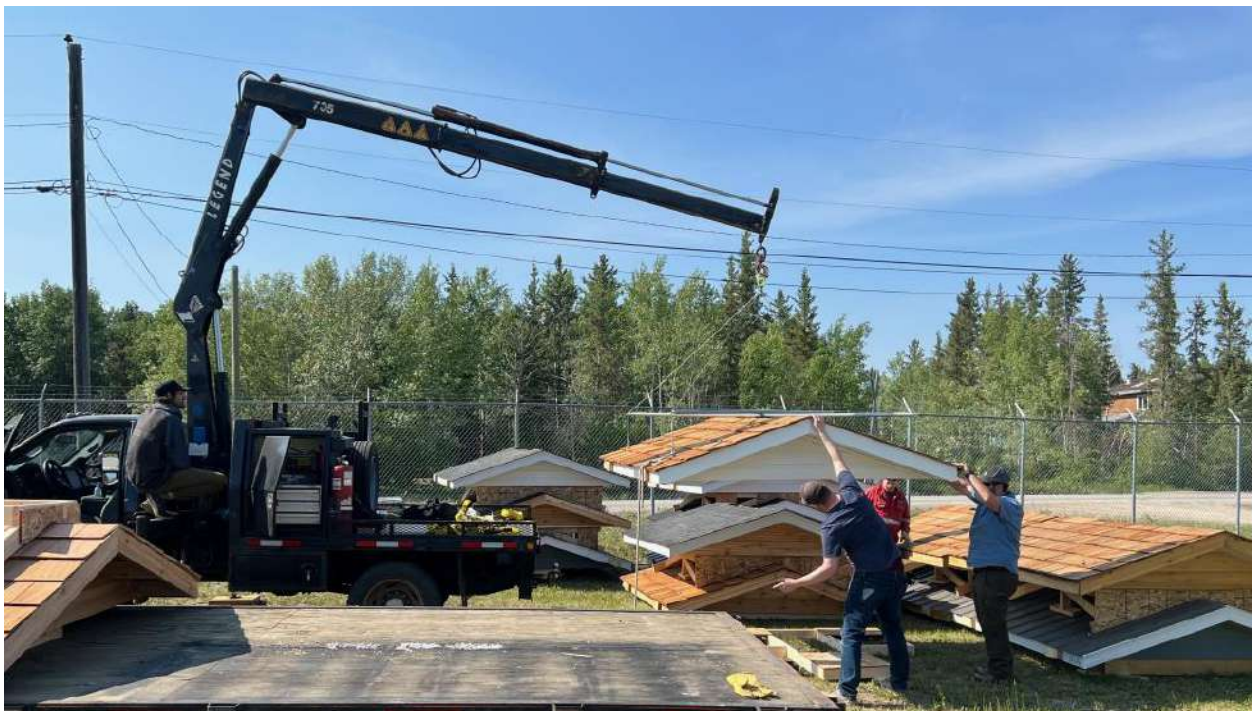
Figure 16 Roof System being Unloaded in Compound in Ft. Providence NWT (June 2023)

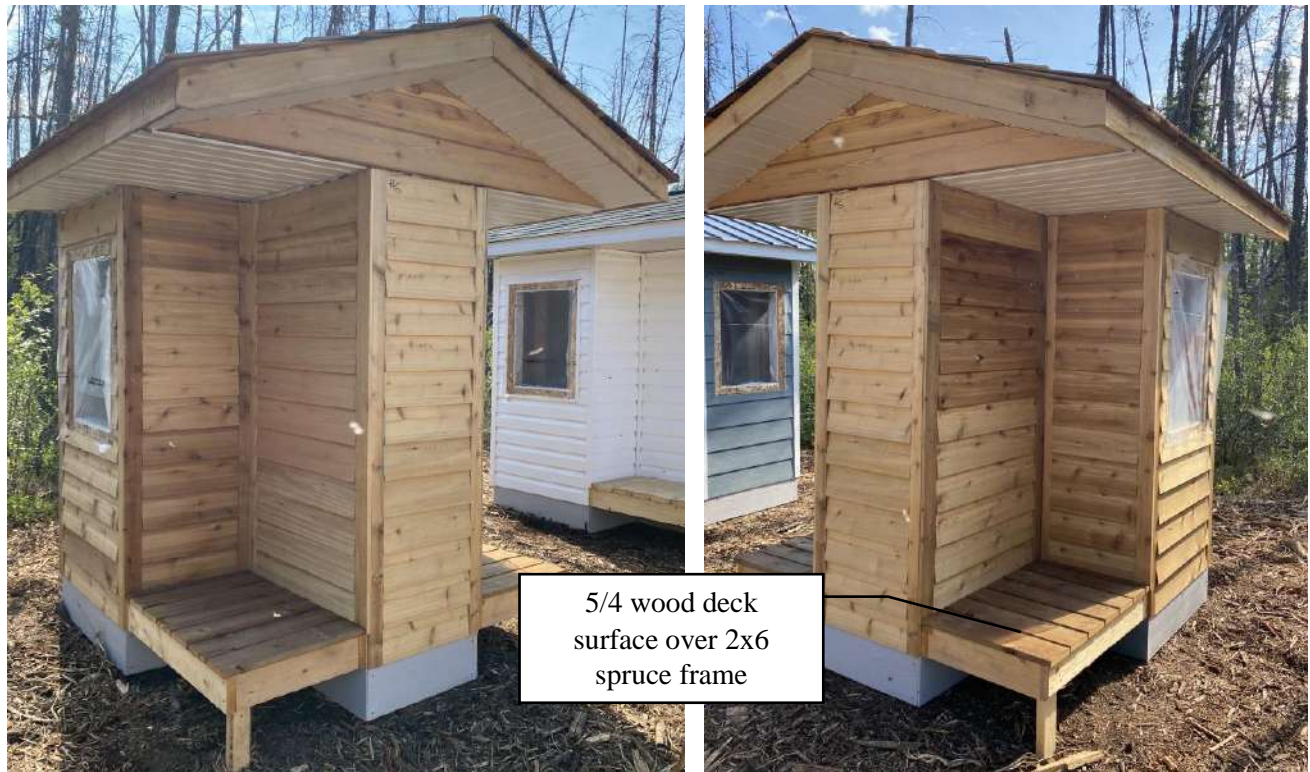
Figure 20 Rear View of Vulnerable Cabin

The vulnerable cabins were covered in cedar on both the walls and roof as indicated in Figures 19 and 20. Fascia was constructed using cedar boards and soffit material used was vinyl. No drip edge was used with these structures. Attic venting consists of a ridge vent and soffit vents (in the vinyl soffits). The fine mesh supplied with the ridge vent was removed so maintain a minimum 6 mm opening size.

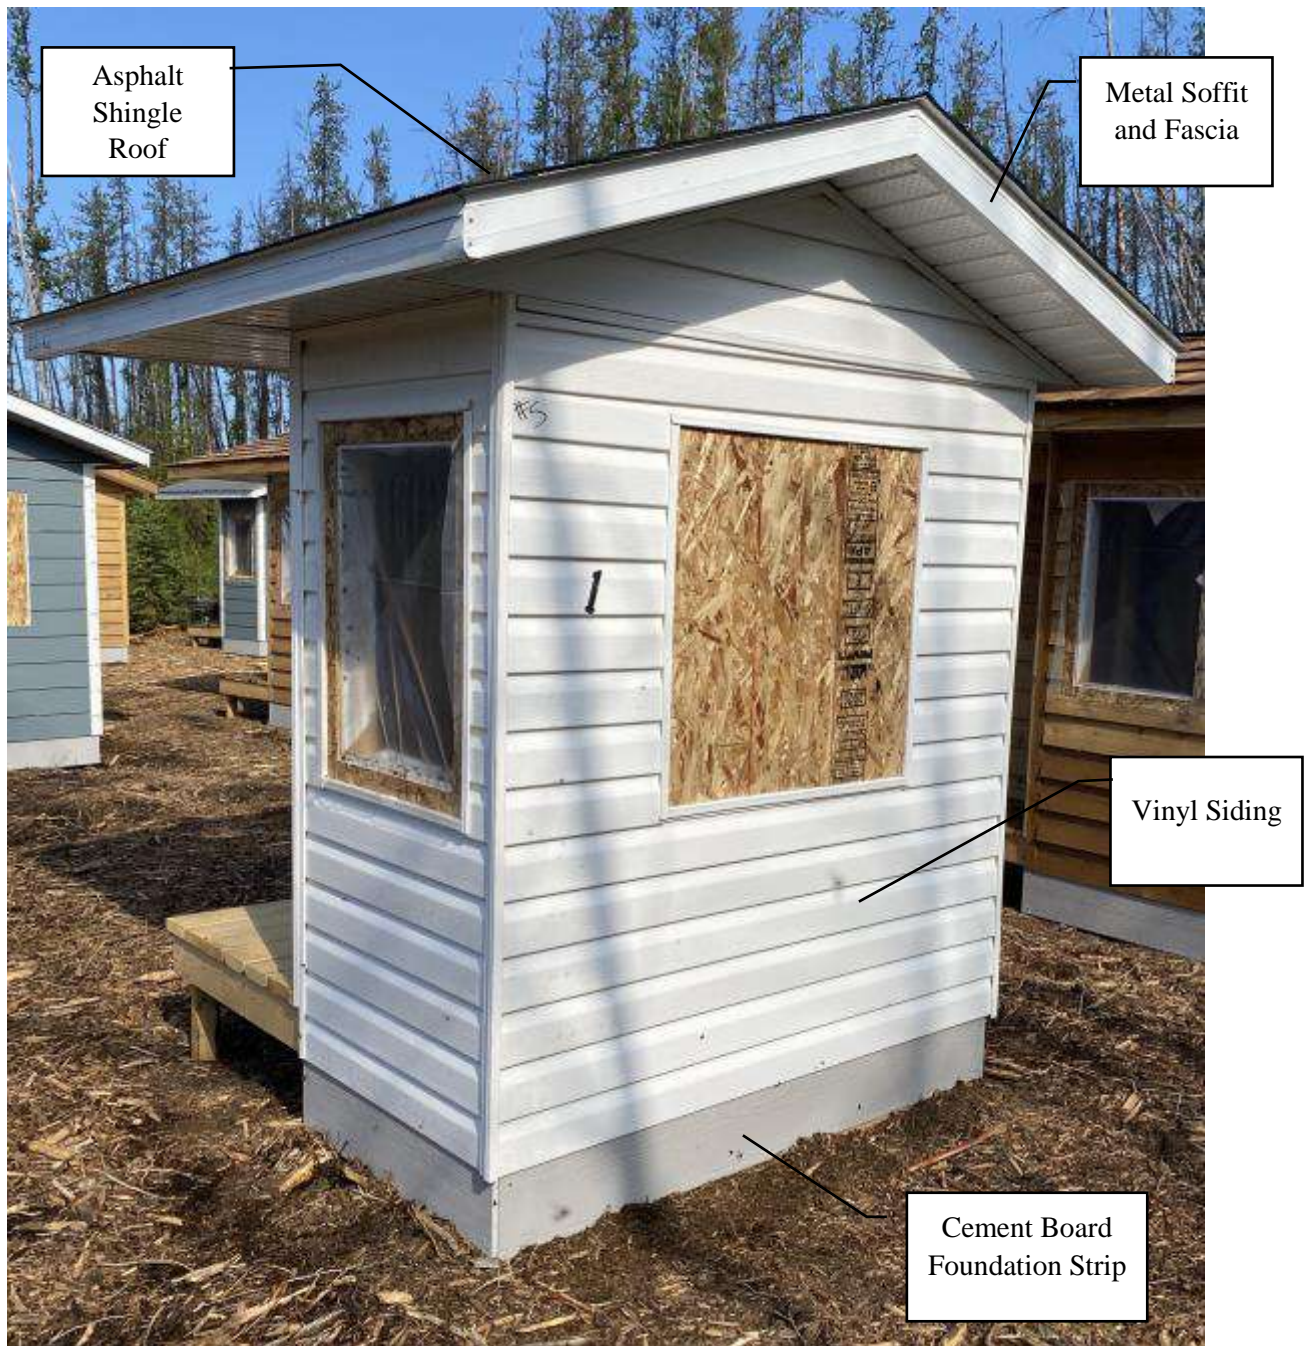
Figure 21 Front View of Present Day Cabin

Present day cabins were constructed with the same basic frame as the rest of the test buildings. The differences between these and the vulnerable cabins is that these use vinyl siding, an asphalt shingle roof, metal soffit and fascia, and a spruce deck (framing and surface). A metal drip edge was used at the edge of the roof. Figures 21 and 22 show the basic structures with details highlighted.

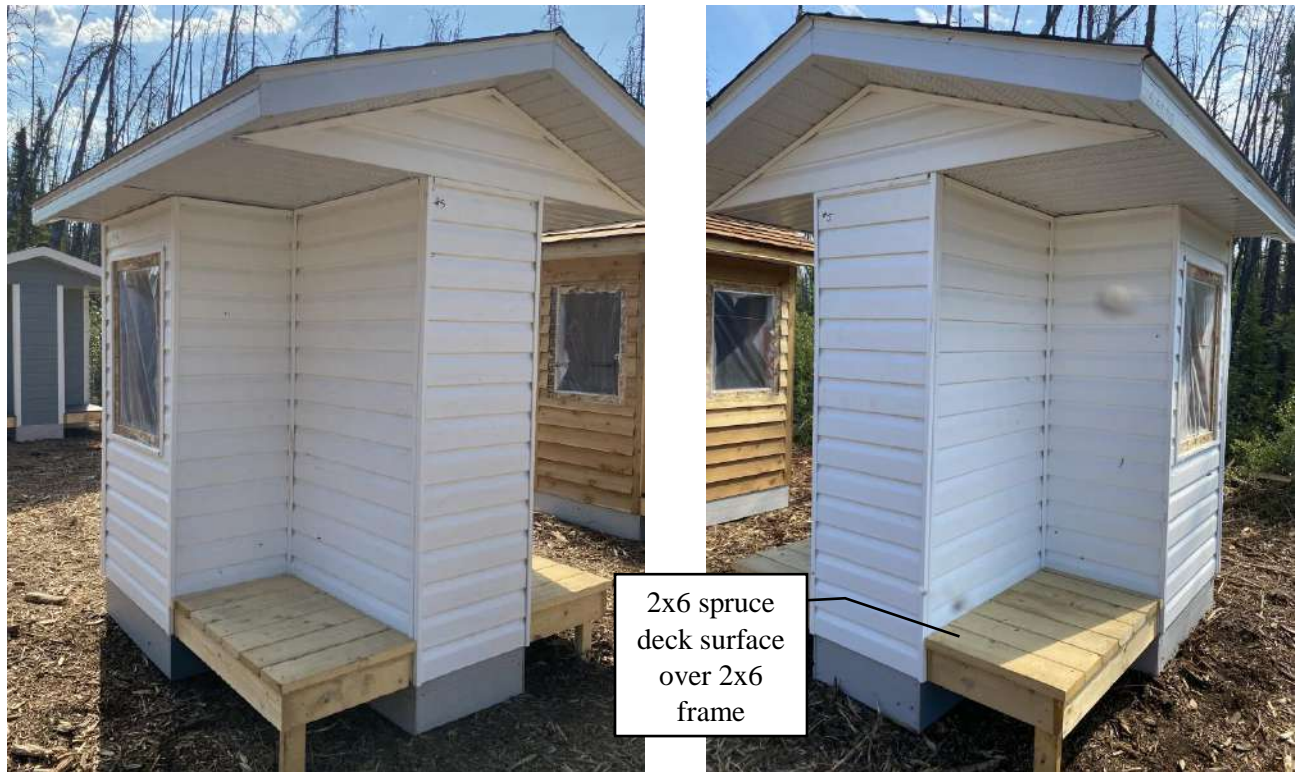
Figure 22 Rear View of Present Day Cabin

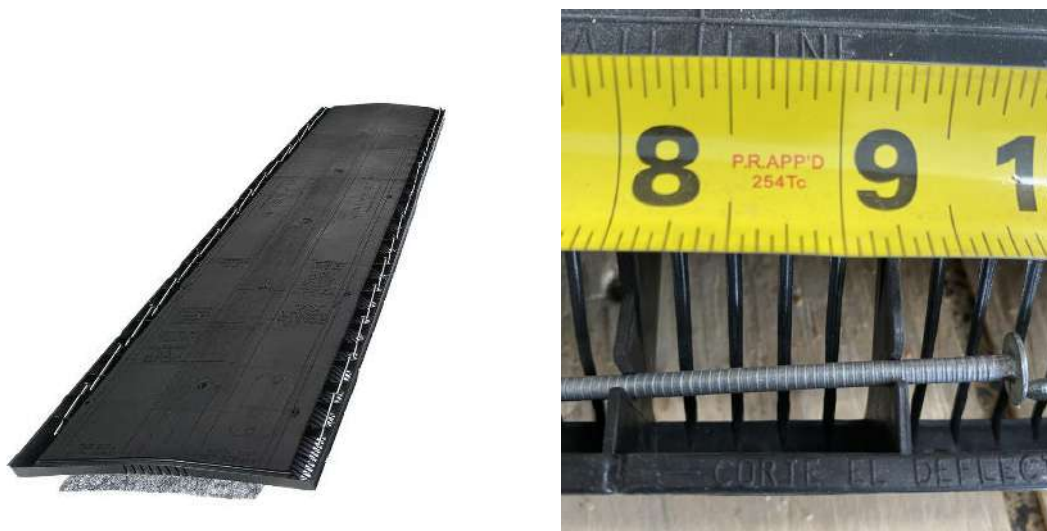
Attic venting consists of ventilated soffits and a 1200 mm (48") ridge vent that has 6mm openings (Figure 23). In the present day cabins the mesh was removed to maintain a 6mm opening size.

Figure 23 Gaf Ridge Vent Used in both Vulnerable and Present Day Cabins

Windows are dual pane, sealed, vinyl framed, on both the front and sides. The deck was constructed using nominal 2x4 spruce boards as a surface over a 2x6 spruce frame. A 200 mm tall strip of cement board was placed around the perimeter at ground level to simulate a foundation. Attic ventilation consists of perforations in the soffit as well as a ridge vent (nominally 1200 mm long) with 6 mm openings as was shown in Figure 23. The fine mesh supplied with the vent was removed to maintain 6 mm openings.

The wood deck was constructed using 5/4 treated wood decking material as a surface over a 2x6 spruce frame. Attic ventilation consists of a ridge vent (Figure 23) with the fine mesh insert removed to preserve 6 mm openings. There were no soffits used in this cabin but ventilation is provided using several 75 mm diameter holes covered with a nominal 6 mm mesh spacing screen as indicated in Figure 34. The soffit area above the deck on each side is 9.5 mm thick oriented strand board (OSB).

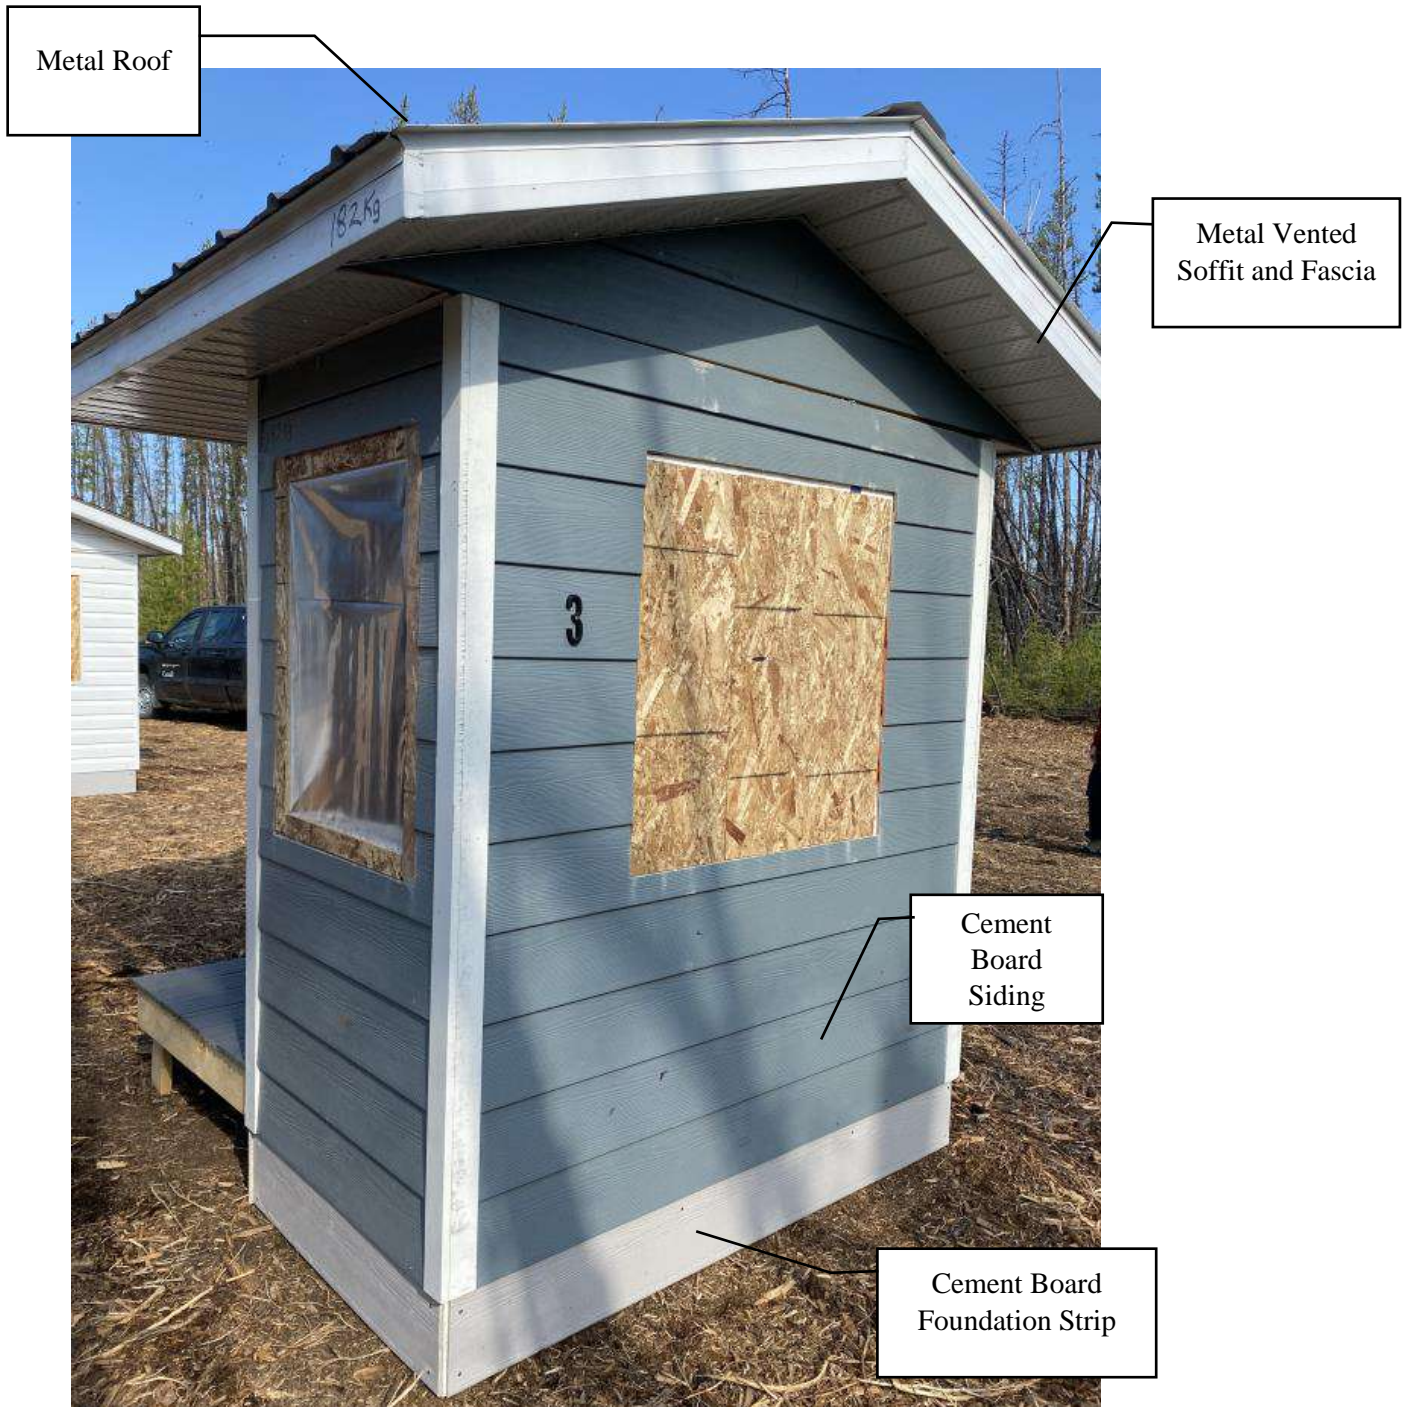
Fire resistant cabins were constructed using materials that are considered less vulnerable to either embers or direct flame. Exterior finish was cement board (Hardie board), roof surface is metal and both soffits and fascia are metal. A metal drip edge was used around the edge of the roof. Attic venting consists of vented soffits and a ridge vent using a 3 mm metal screen to prevent ember entry.

Figure 24 Front View of Fire Resistant Cabin

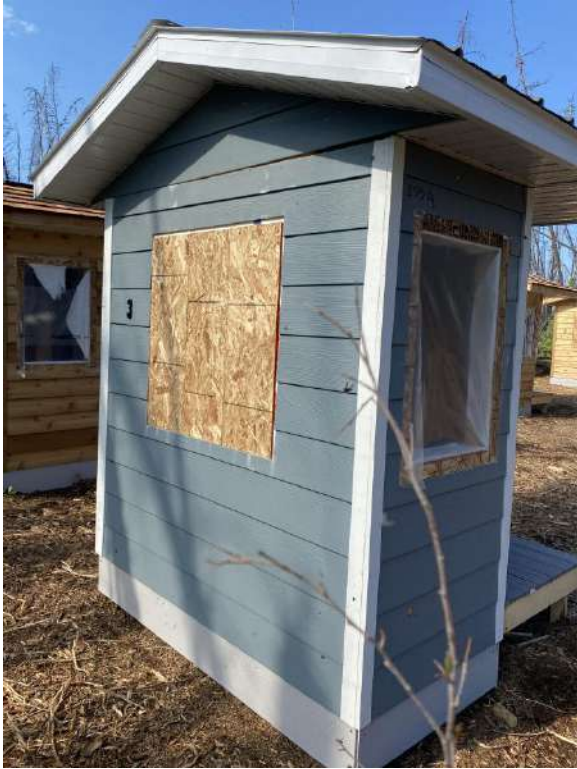
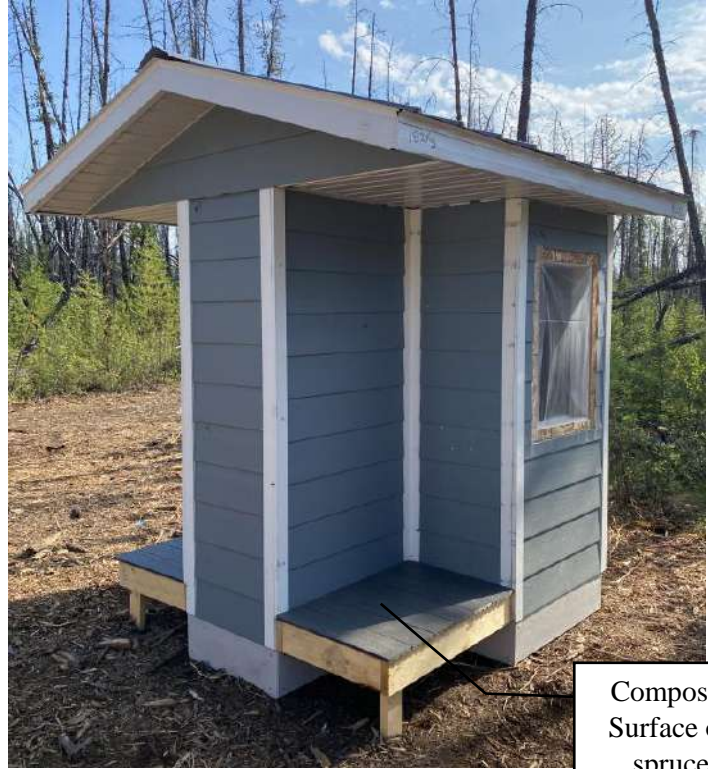
Figure 25 Additional Views of Fire Resistant Cabin

Windows for the structure are vinyl framed, dual pane, sealed units. Wood framed windows were considered but are rarely used in new construction.

As with all of the cabins a cement board strip (~200 mm) was placed around the base of the structure. The decks were constructed using composite boards over a spruce frame. The decks will be completed with the installation of a non-combustible skirt that will prevent any accumulation of embers below. This was not done during the initial installation but will be completed prior to testing.

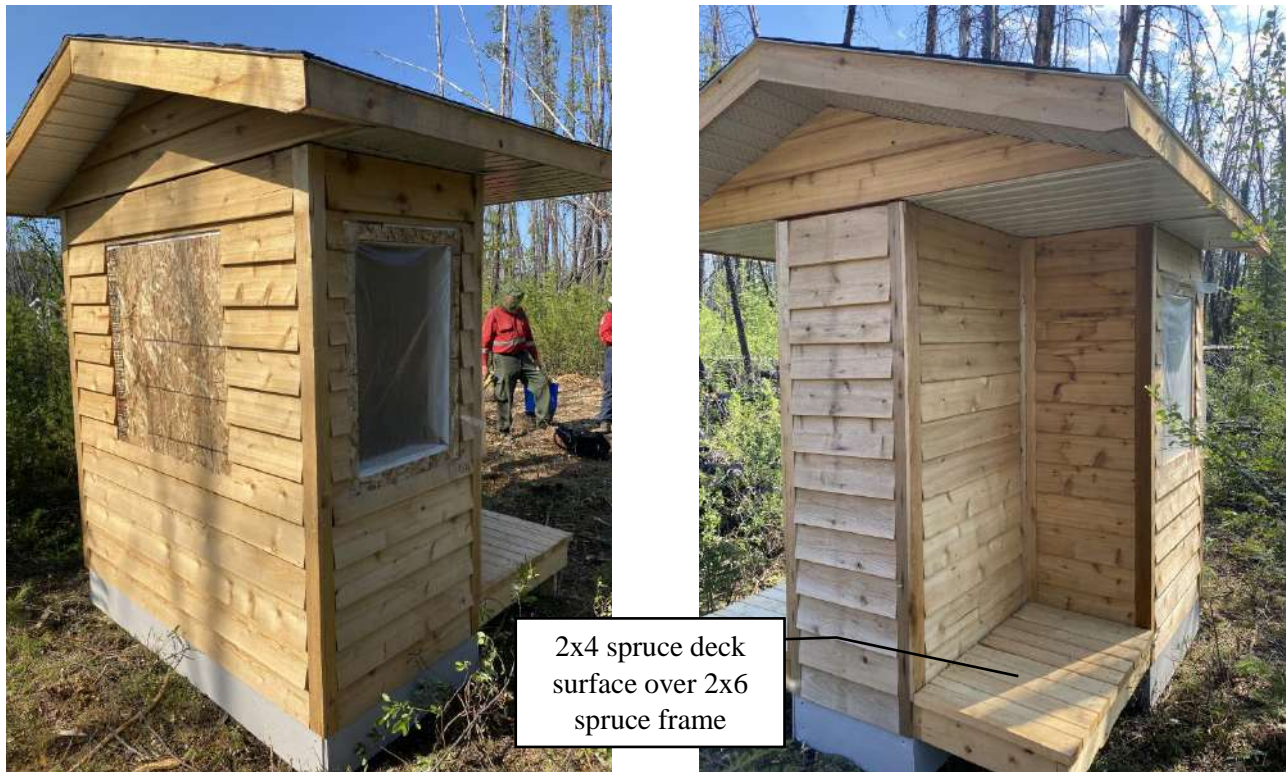
Figure 27 Additional Views of Cabin 10

Windows are dual pane, sealed units, with vinyl frames. Decking consists of nominal 2x4 spruce as a surface over a spruce frame. As with all of the cabins, a 200 mm cement board strip was placed around the base of the perimeter to simulate a foundation.

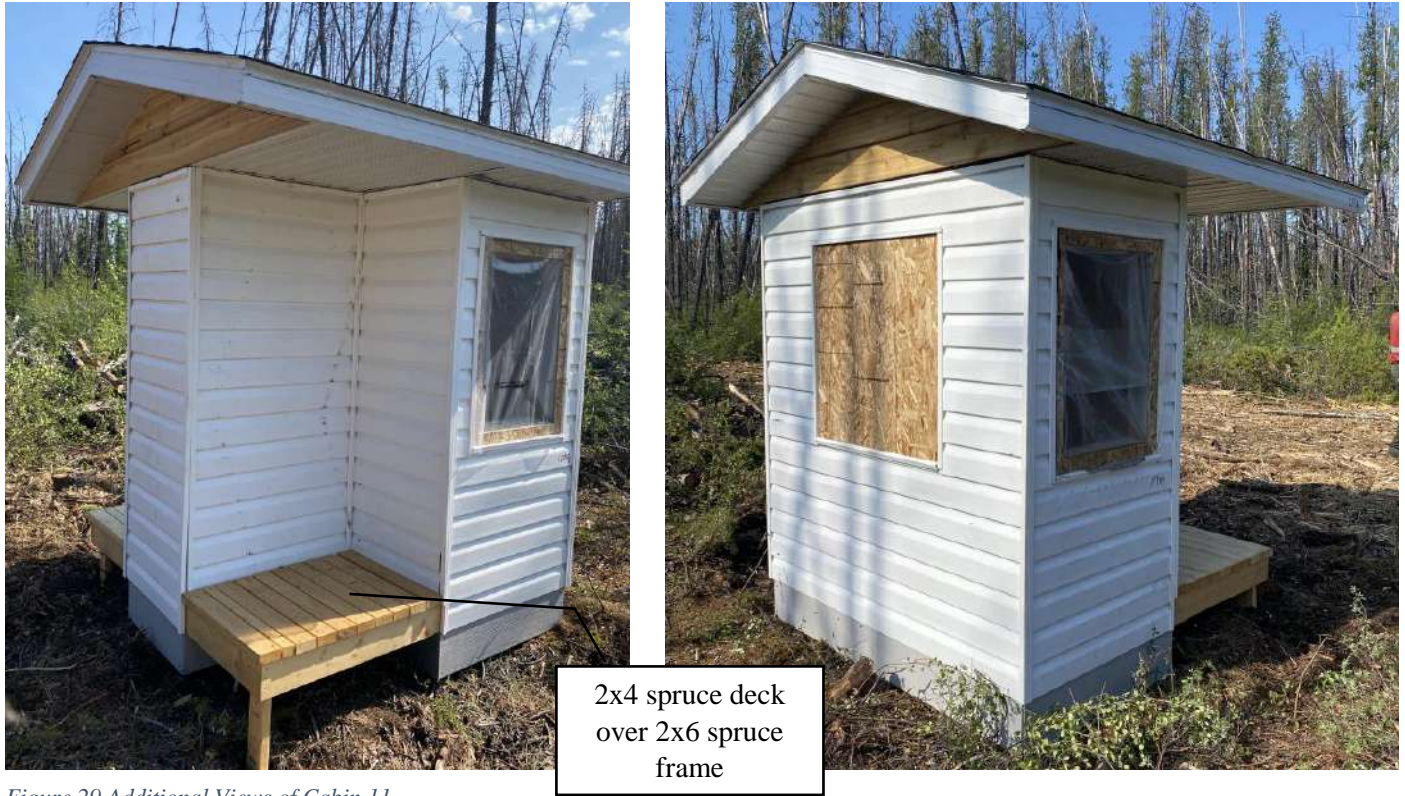
Figure 29 Additional Views of Cabin 11

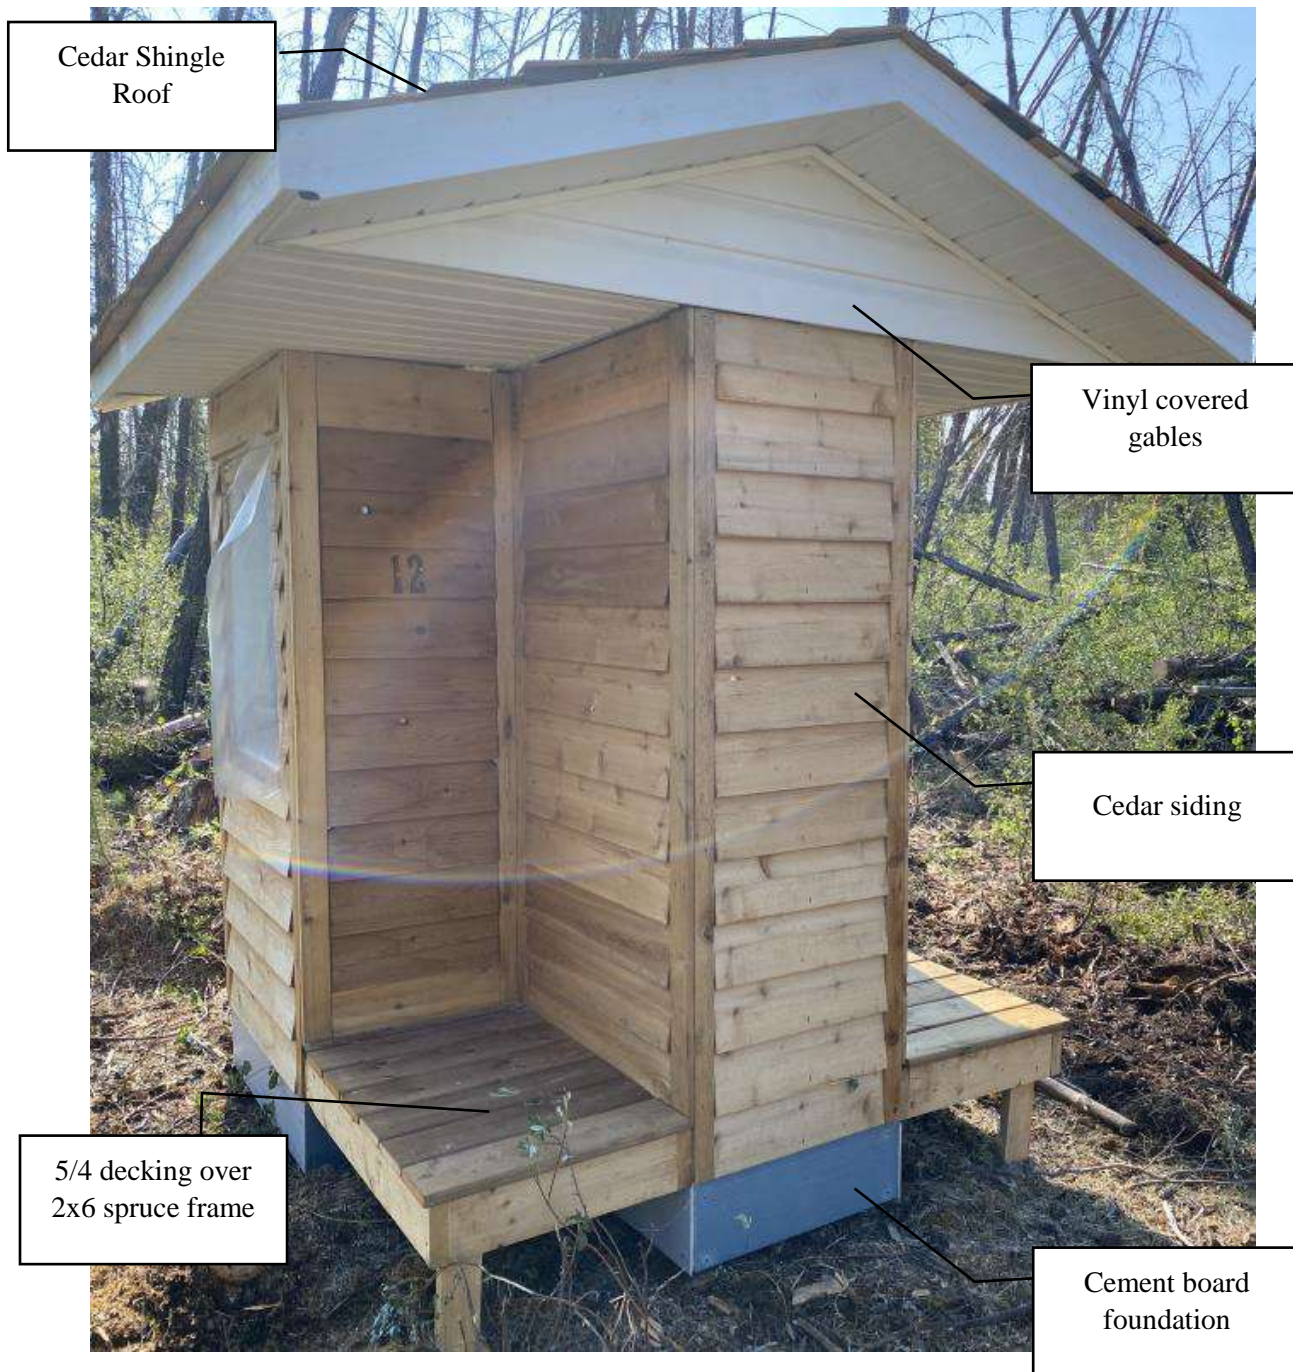
Cabin 12 (Figures 30 and 31) used cedar siding and a cedar shingle roof. No metal drip edge was used on the roof. Soffit and fascia were both vinyl.

Figure 30 Rear View of Cabin 12

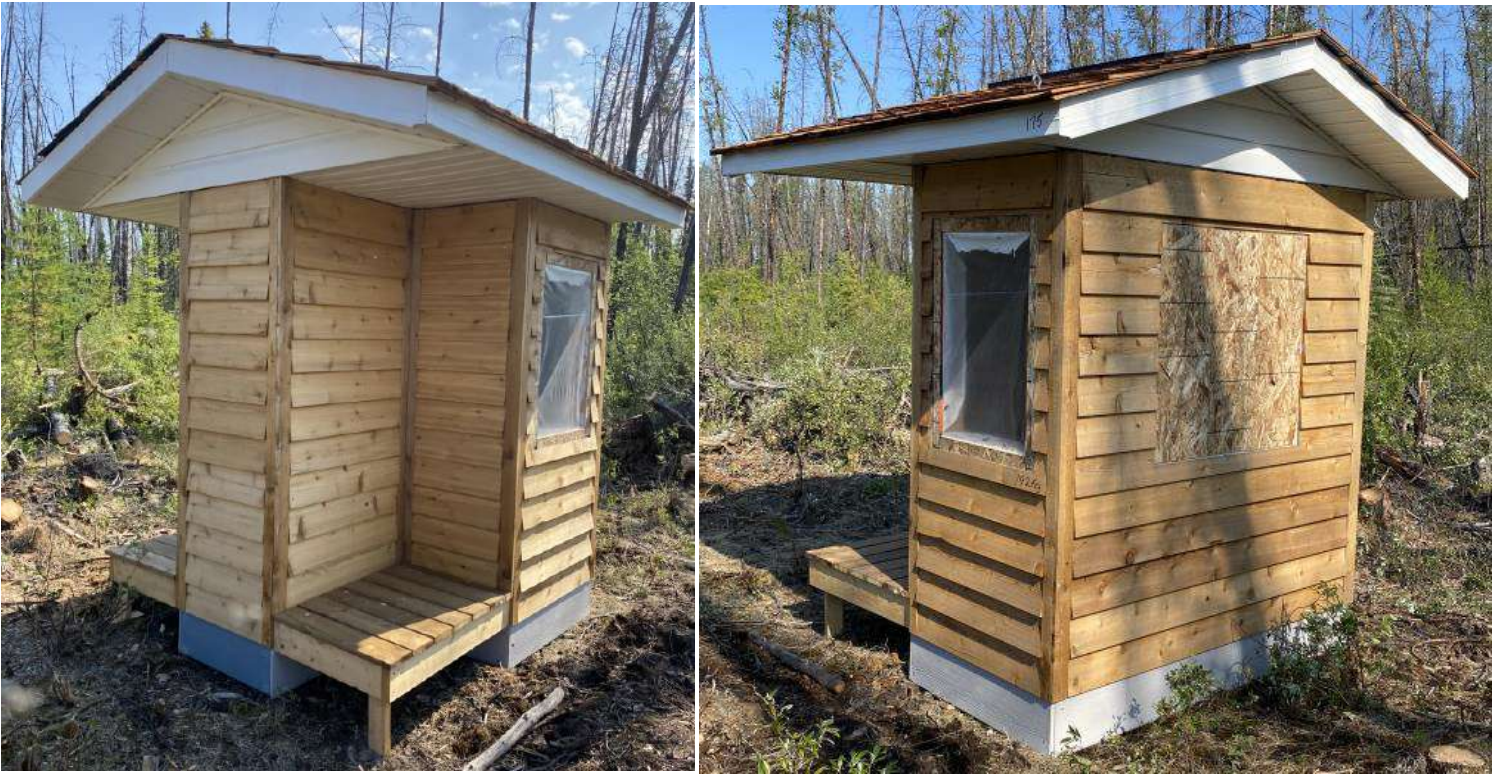
Figure 31 Additional Views of Cabin 12

The decks were constructed using 5/4 treated wood as a surface over a nominal 2x6 frame. A 200 mm cement board was placed around the perimeter at ground level to simulate a foundation. Windows are dual pane, sealed units with vinyl frame. Attic ventilation consists of a ridge vent with 6 mm openings as well as perforations in the vinyl soffit material.

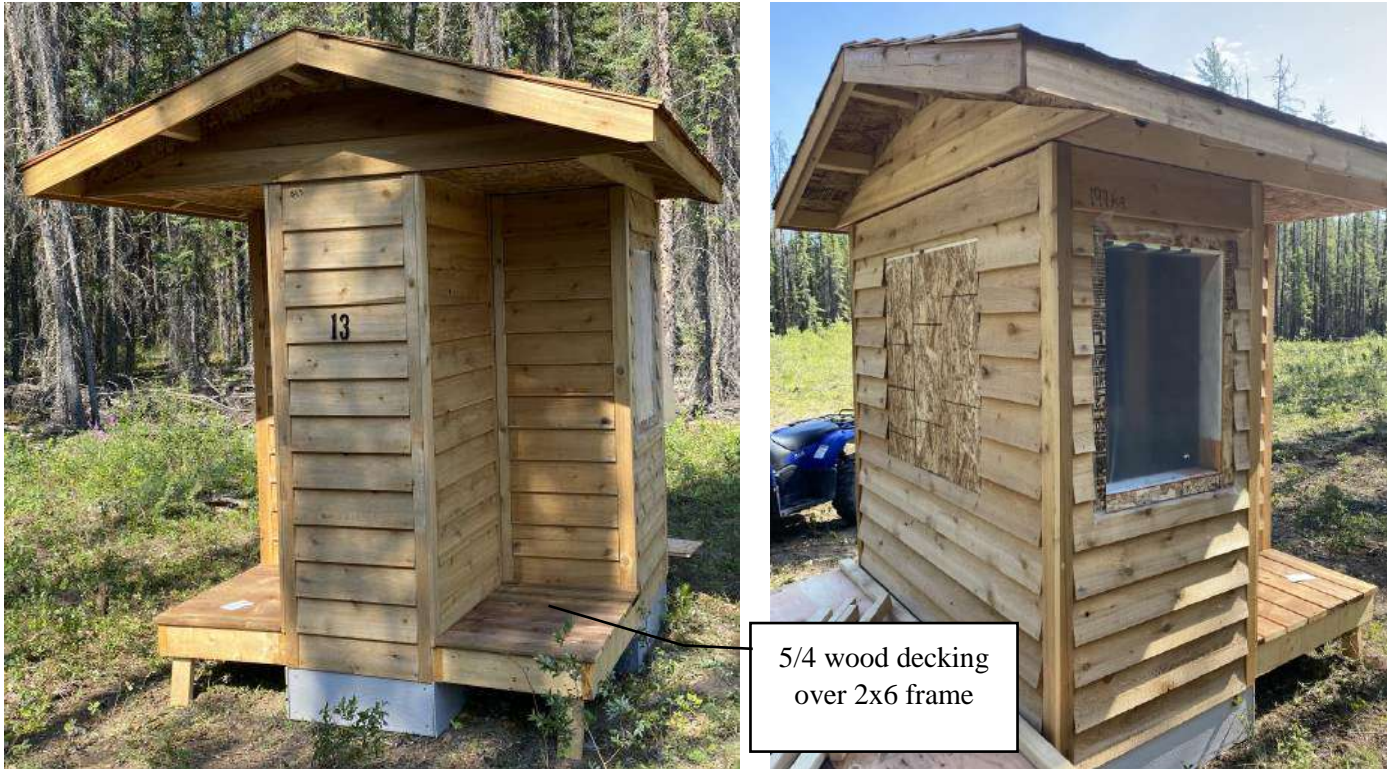
Figure 33 Additional Views of Cabin 13

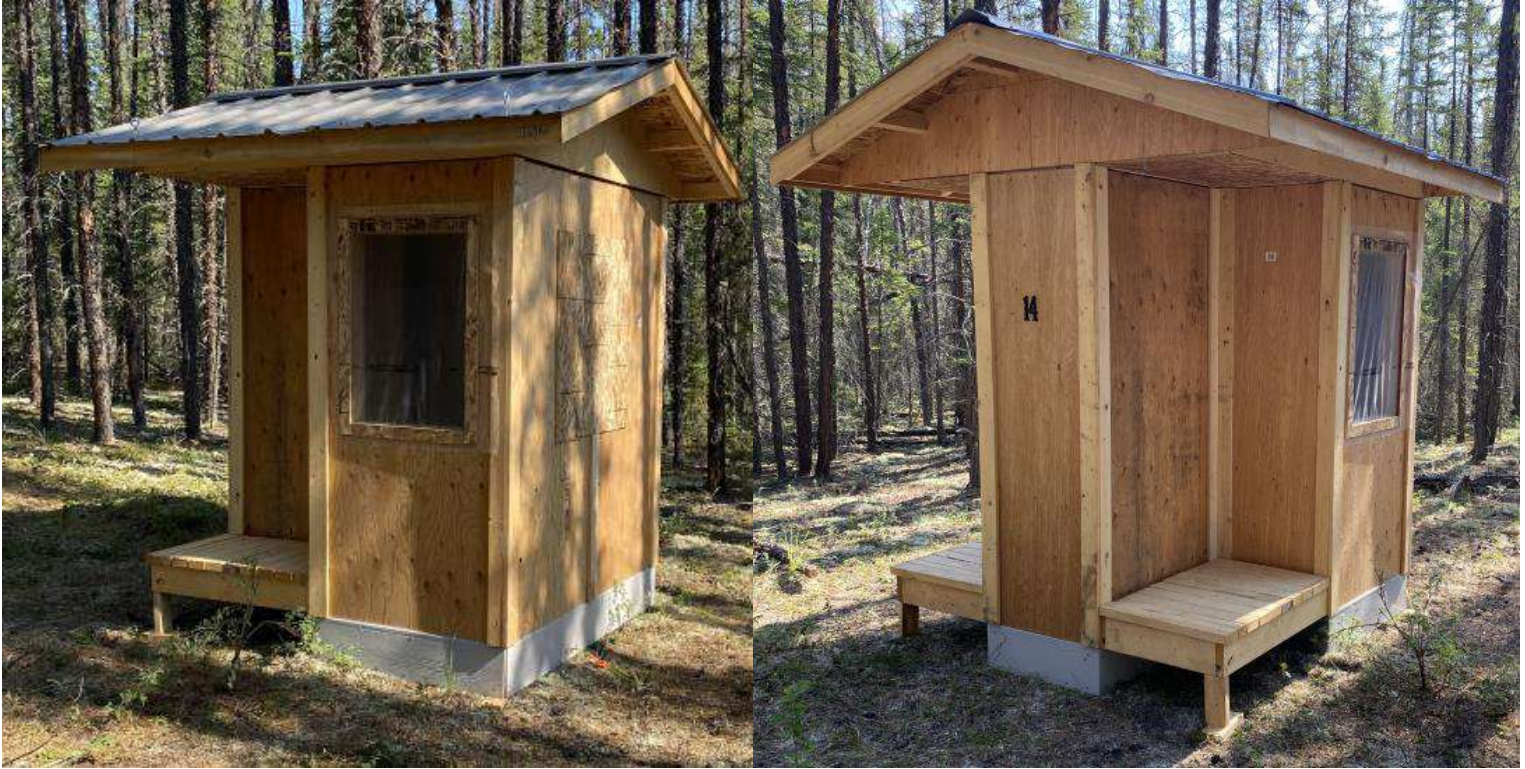
Figure 36 Additional Views of Cabin 14
